CASE STUDY

Stoney Knoll & Gloverfield

Client: Salix Homes

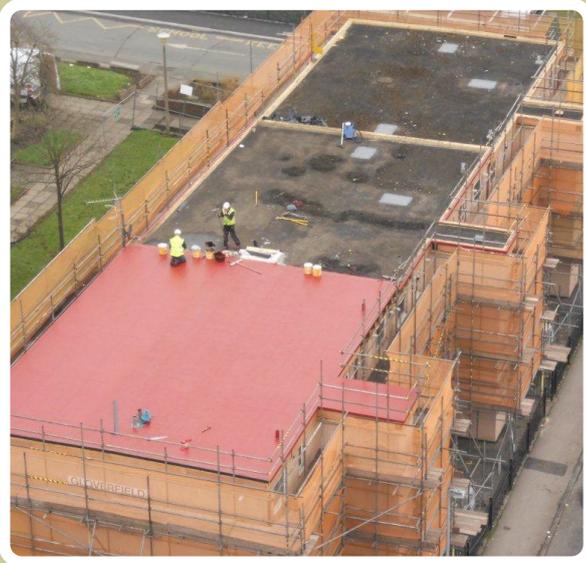
The flat roofing system was designed by Sika and consisted of 130mm of PIR insulation board covered by a decothane roof membrane.

The flat roofing system was designed by Sika and consisted of 130mm of PIR insulation board being laid onto the existing roof structure before being covered by a cold applied decothane roof membrane. The system was installed without the need to remove the existing coverings so no leaks in the existing structure took place.

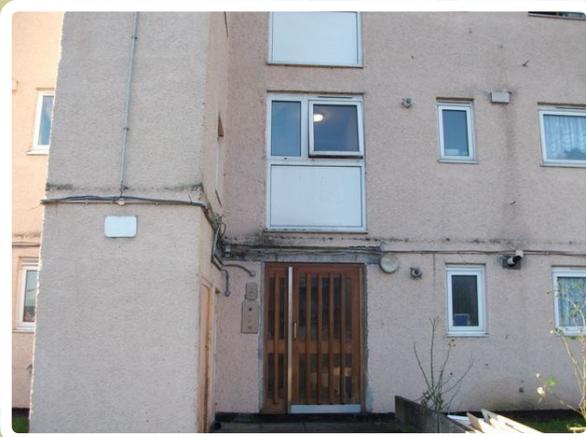
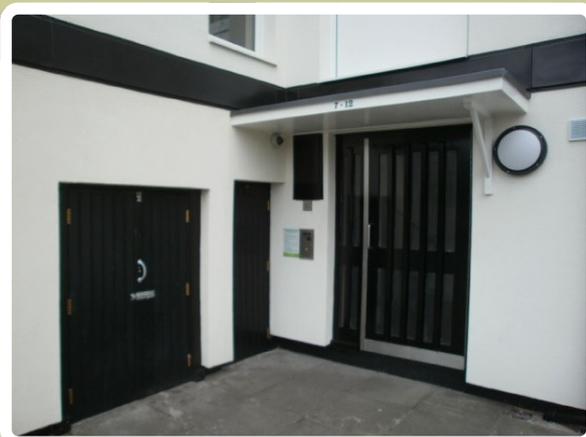
Before and after: with a bespoke cable GRP trunking and insulated render

Following on from this we installed 3,000m² of 110mm Expanded polystyrene insulation to all the external walls using mechanical fixings and wet bedding. The walls were finished with ST Silkolitt silicone render in off-white with a rolled texture. The external wall system was designed by Alumasc.

Another challenge we encountered was the cable trays that went round all the blocks, which contained security camera, CCTV, door entry, cable TV and other various cables. They looked unsightly and had trailed in parts due to poor maintenance. Access is needed to these cables so we designed a GRP trunking with a colour matched removable lid that could be applied and removed, in parts as necessary. This trunking made a marked improvement to the appearance of the block.
